HYDRAULIC INJECTION INCIDENT

A warning to us all

Aberdeen

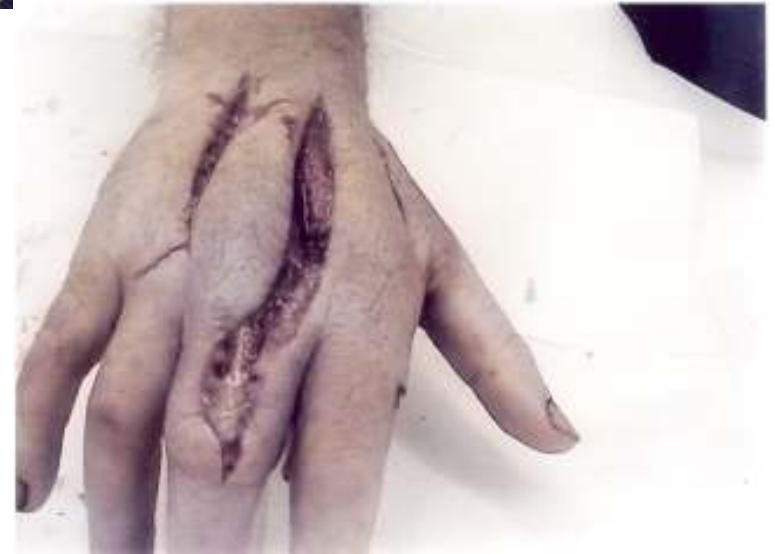
- Training Session under controlled conditions within Brigade Training Premises
- IP was to cut through sample vehicle using scissors.
- Normal practise at time was for the hydraulic hose to be run over operators shoulder to tool in use.
- Hose ruptured at ferrule area resulting in release of fluid through PPE (Leather gauntlets) to IPs hand.

- IP was eventually medically discharged from force and is severely disabled in this hand.
- Hydraulic Fluid in use has been changed to “Aero Shell Fluid 4”.
- Fire Brigade has passed learning's on to its associated Brigades.
- Litigation is in place:
 - IP to Brigade
 - Brigade to Equipment Manufacturers.
- IP awaits final outcome
- Timescale: 2 years and counting

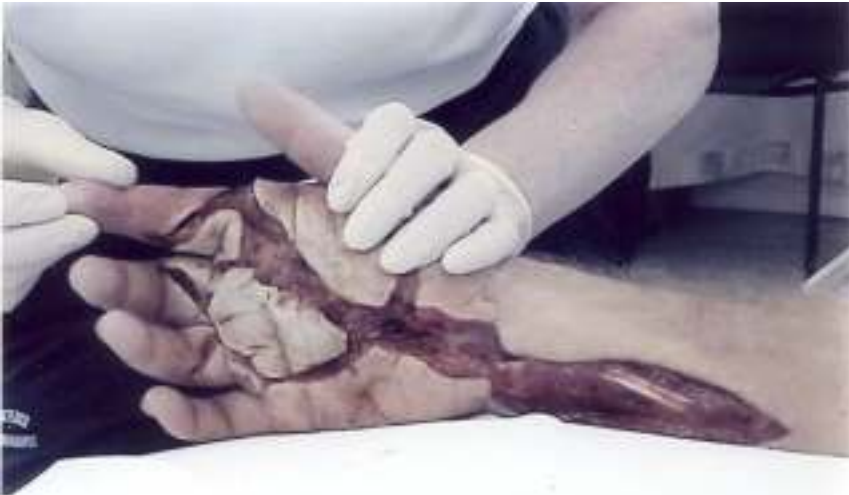
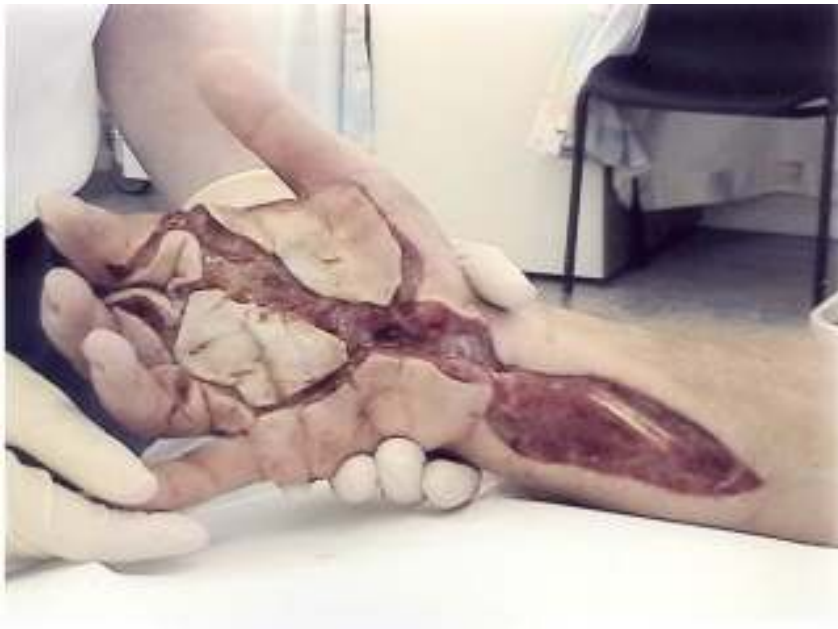
- IP went to A&E and initial prognosis was “keep clean and rest”.
- By chance a specialist observed and intervened.
- Mineral Oil had already started to “eat away” fatty tissues in hand and began travelling through the hand and up the arm.
- IP had 5 operations to cut away oil deposits and was on his last chance before losing arm. It was successful
- Wound could not be sutured due to tissue damage by oil so wound was gradually closed over weeks.
